EFFECTS OF AIRFRAME GEOMETRY
ON DOWNWASH PROBLEMS OF
TANDEM DUCTED-PROPELLER
VTOL AIRCRAFT

DATE Jan. 1964 REPORT NO. 179T80-6

Prepared Under Navy,
Bureau of Naval Weapons
Contract N0w61-0926-c

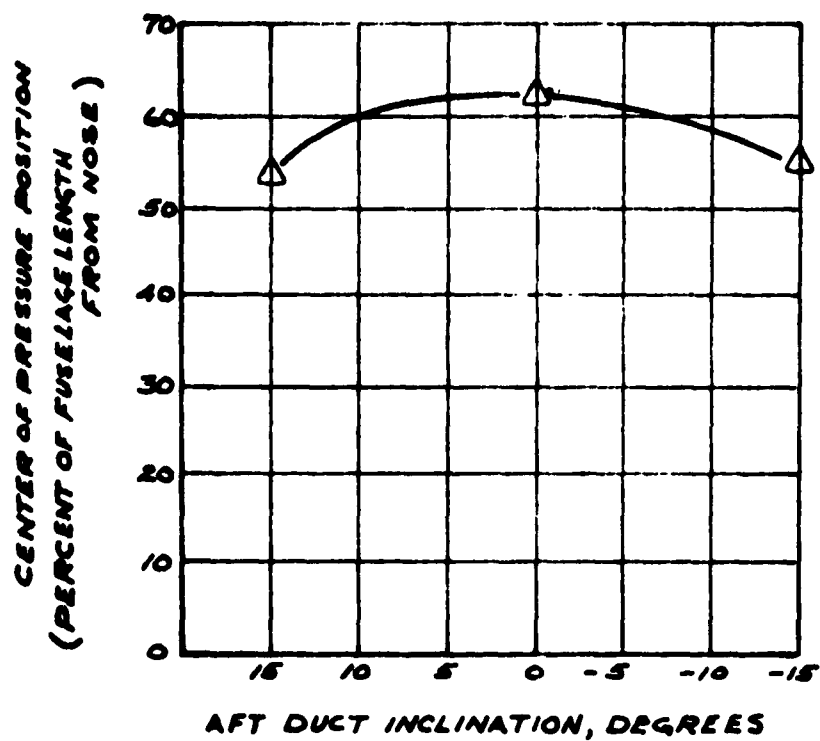
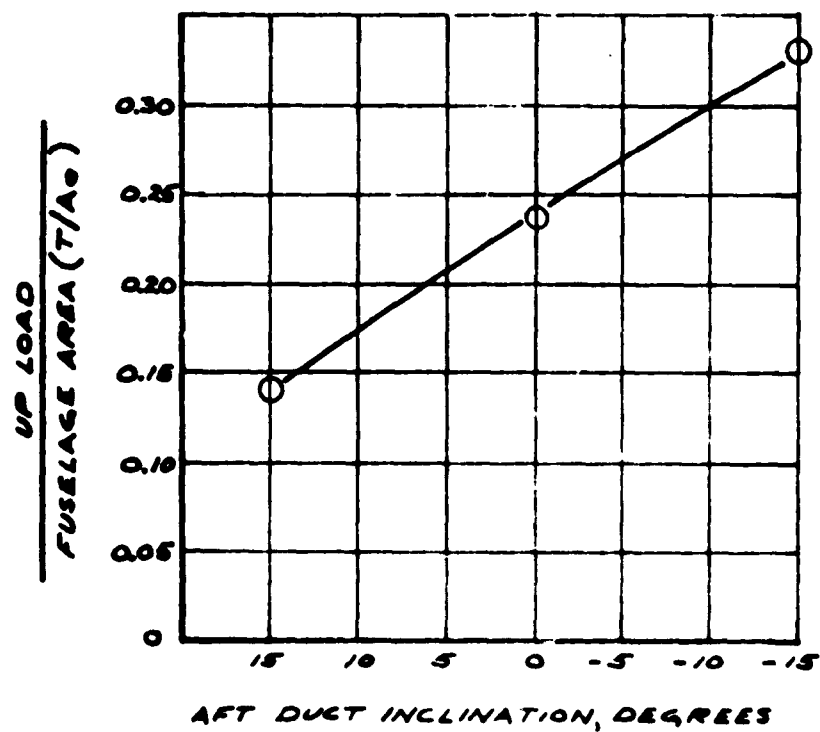
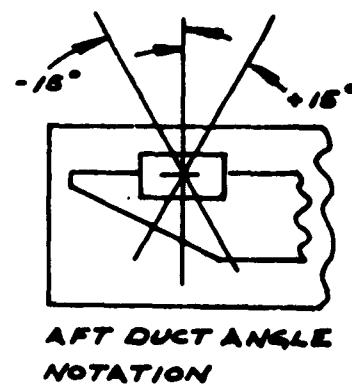
FIGURE 18. EFFECT OF LONGITUDINAL INCLINATION OF AFT DUCT ON FUSELAGE UPLOAD AND CENTER OF PRESSURE

on the fuselage upload and the center of pressure is shown in Figure 18 for the aft duct and Figure 19 for the forward duct. The center of pressure location is not strongly affected by duct tilting. However, the total fuselage lift which is not affected by tilting the forward duct increases considerably when the aft duct is inclined rearward. It should be noted that when one duct was tilted the other duct was held in a vertical position. The results, therefore indicate the effects of individual duct tilting only. However, it is believed that any inclination of the downwash toward the stagnation point under the aircraft will increase the fuselage upload.

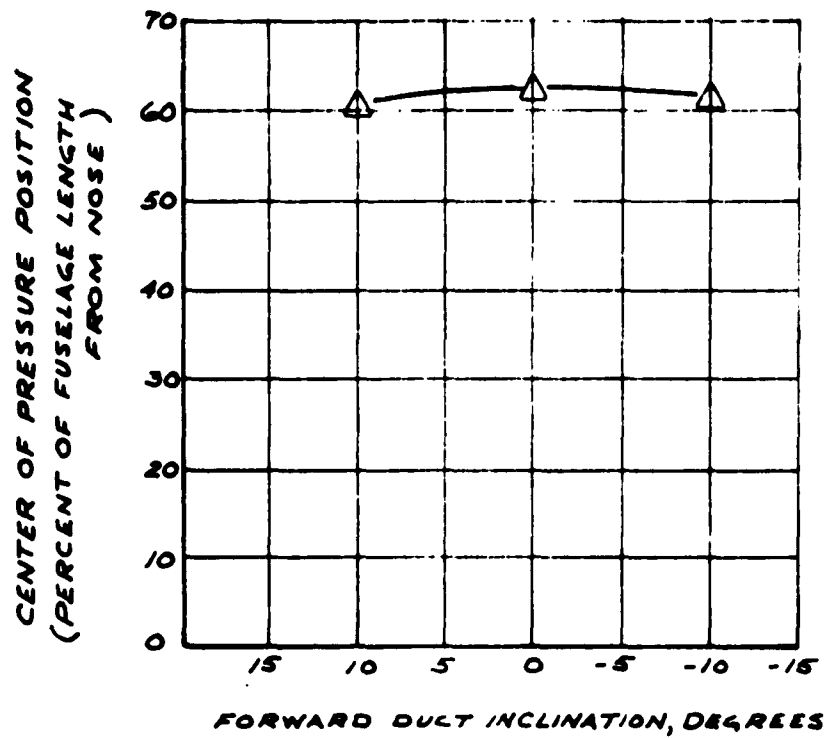
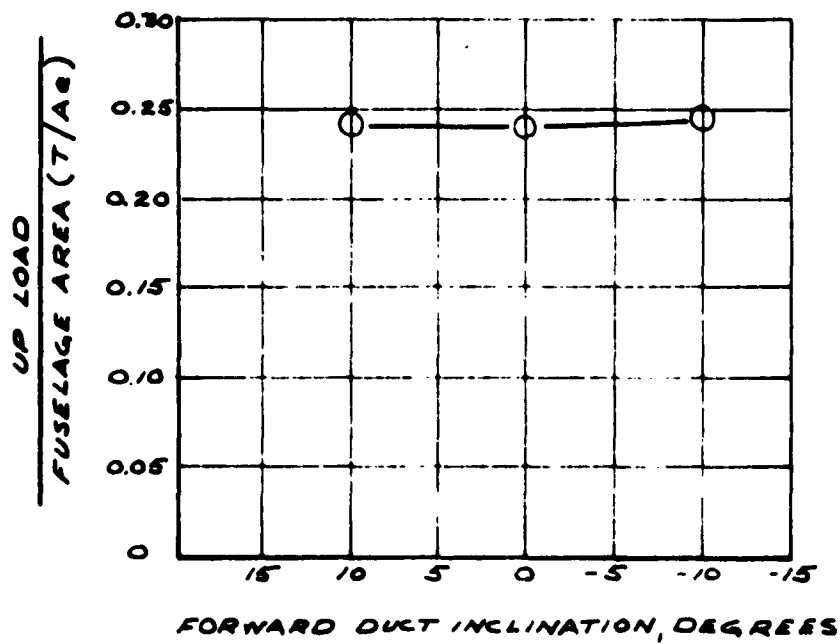
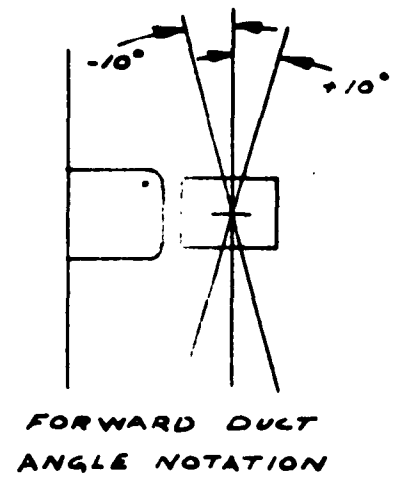
FIGURE 19. EFFECT OF LATERAL INCLINATION OF FORWARD DUCT ON FUSELAGE UPLOAD AND CENTER OF PRESSURE

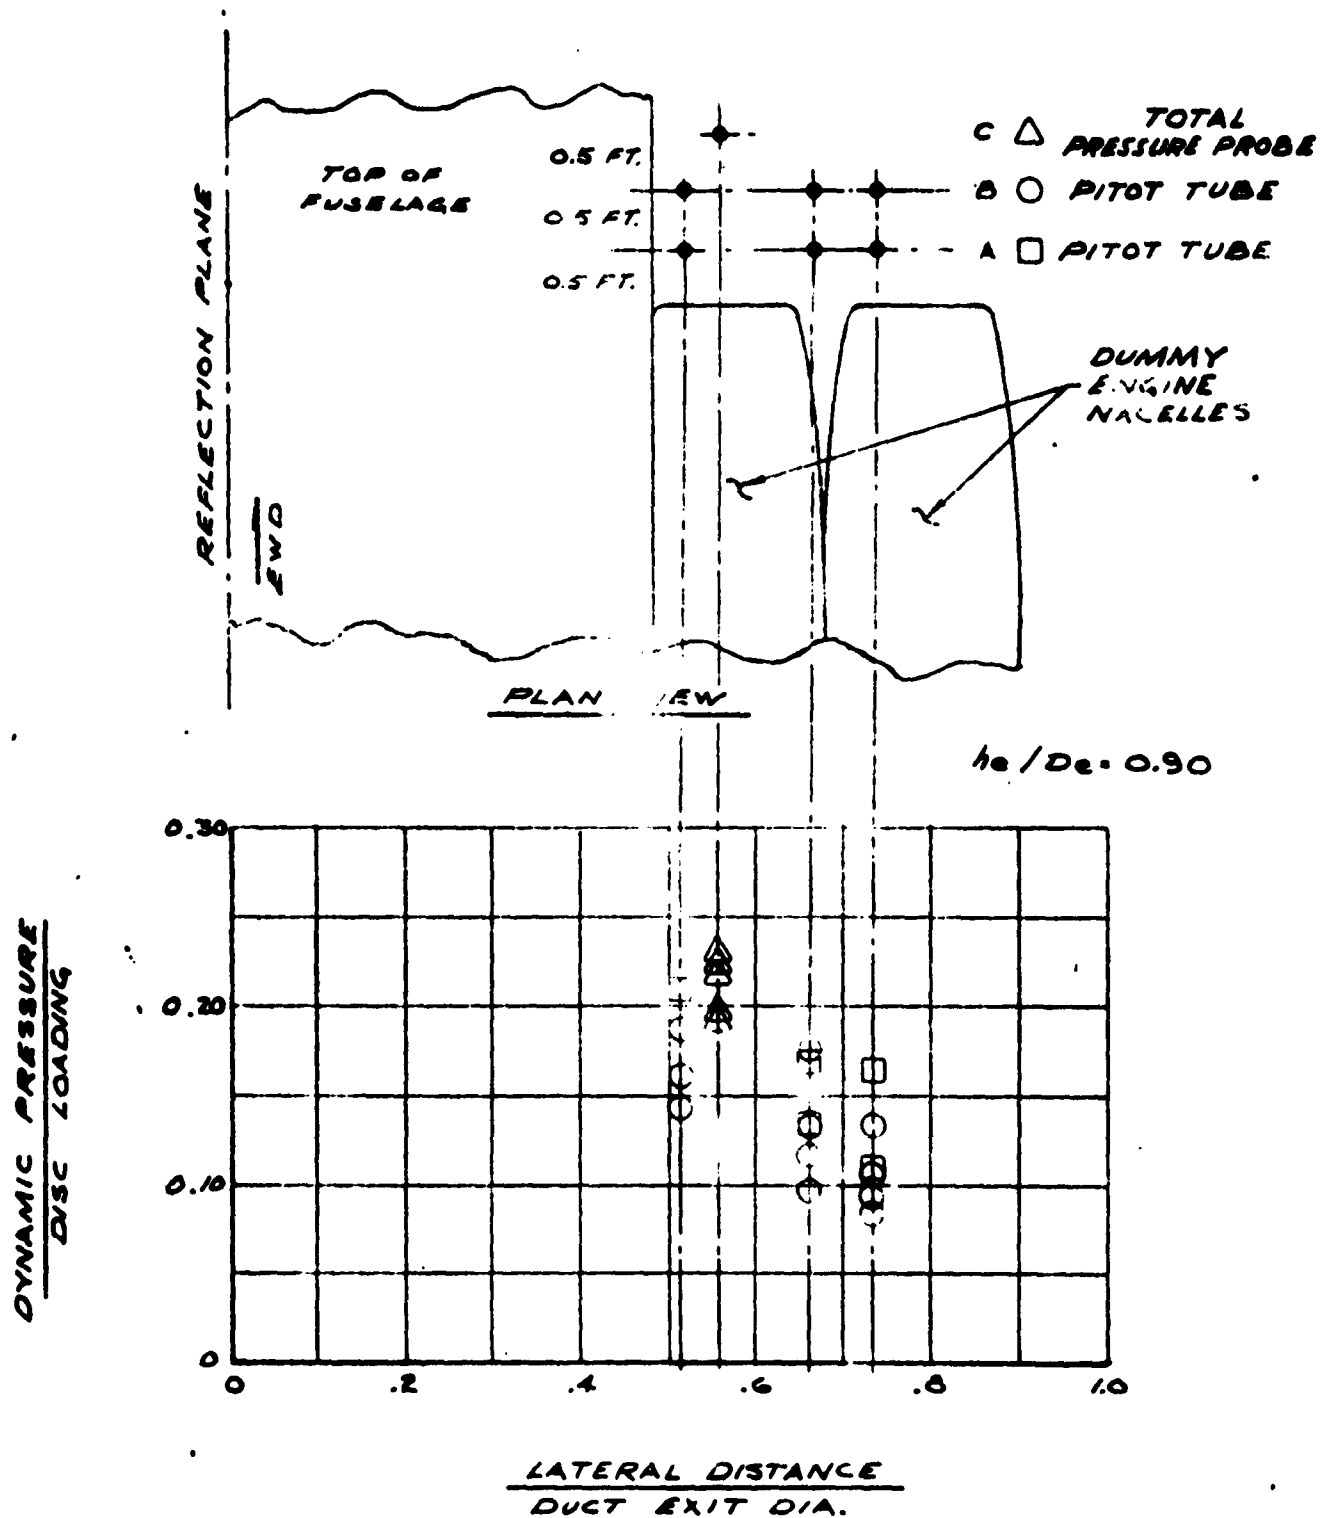
FIGURE 20. DYNAMIC PRESSURE OF UPWASH AT PLANE OF NACELLES.
(1.20 DIA. ABOVE GROUND)

testing. The intakes were located 1.20 exit diameters above the ground level. Figure 20 presents the data obtained and also defines the locations of the pressure probes. The probes were pointed vertically downward and thus the dynamic pressure measurements include only the vertical component of velocity. It is important to recognize that the dummy engine intakes did not provide the given mass inflow demanded by an actual engine. Thus, the pressure distribution obtained in this region under prototype test conditions will undoubtedly be radically different.

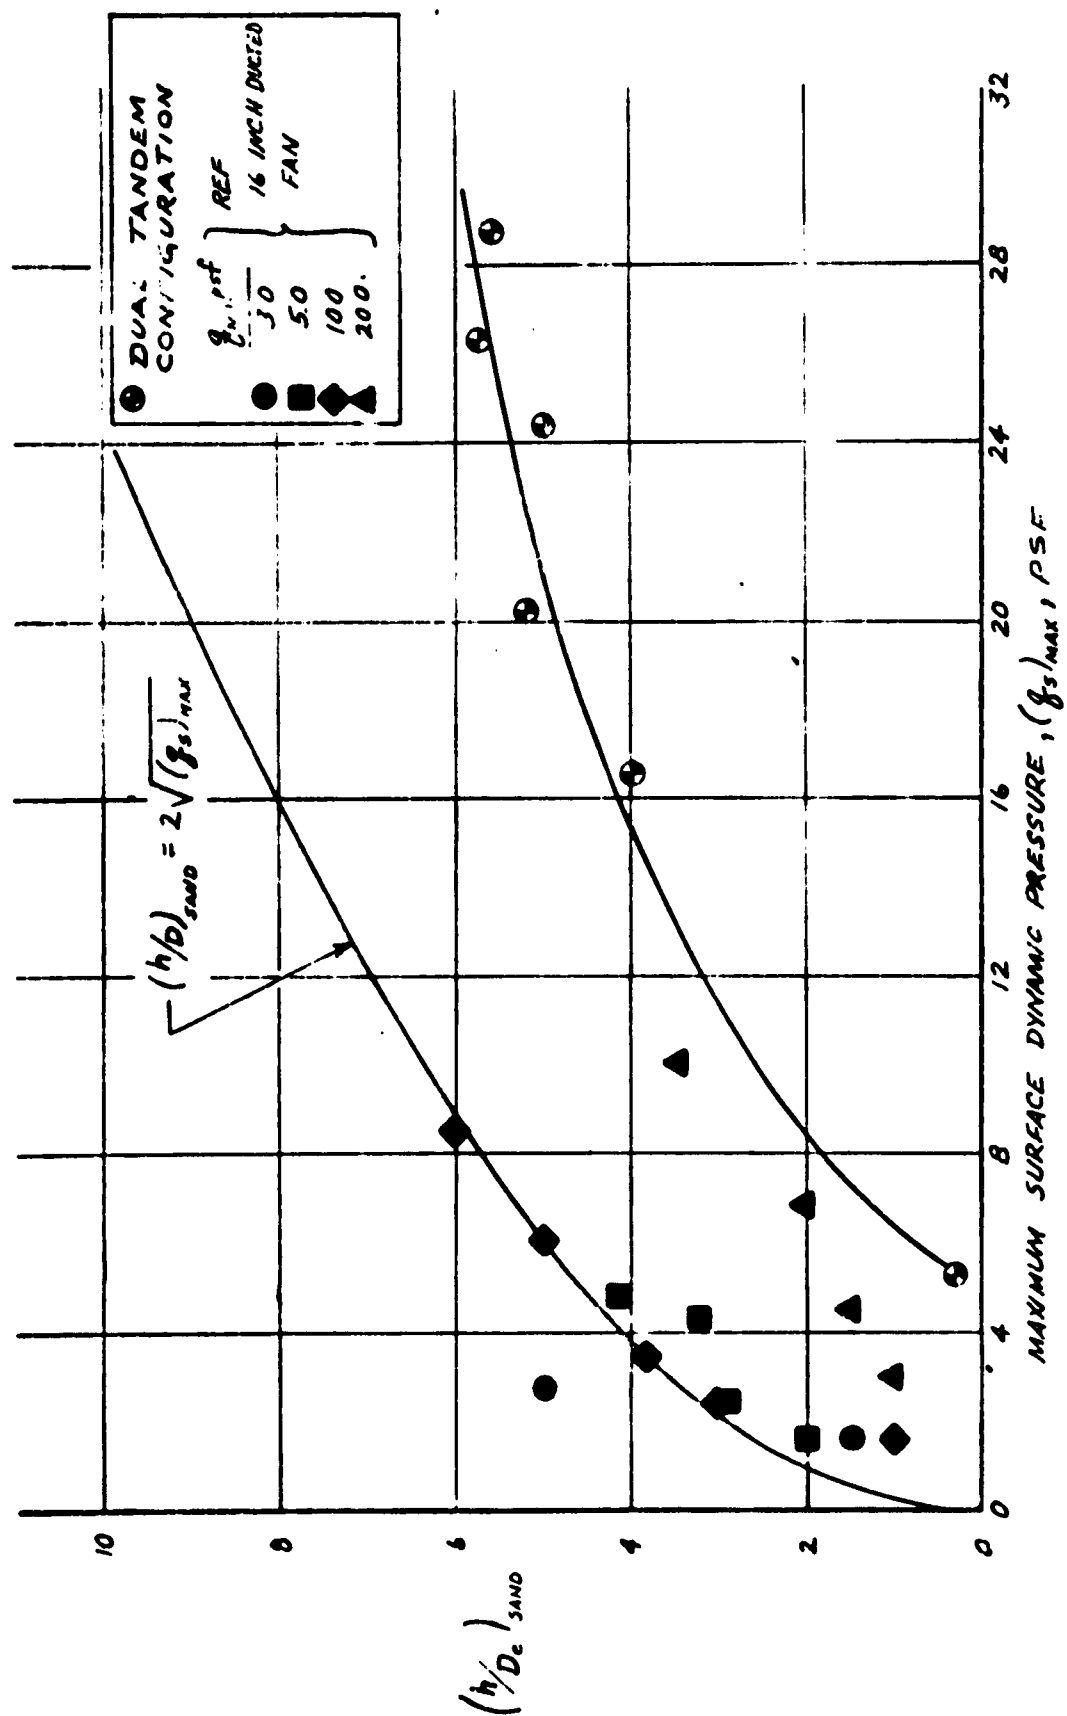
FIGURE 21. HEIGHT WHICH SAND CLOUD ATTAINED FOR VARIOUS SURFACE DYNAMIC PRESSURE

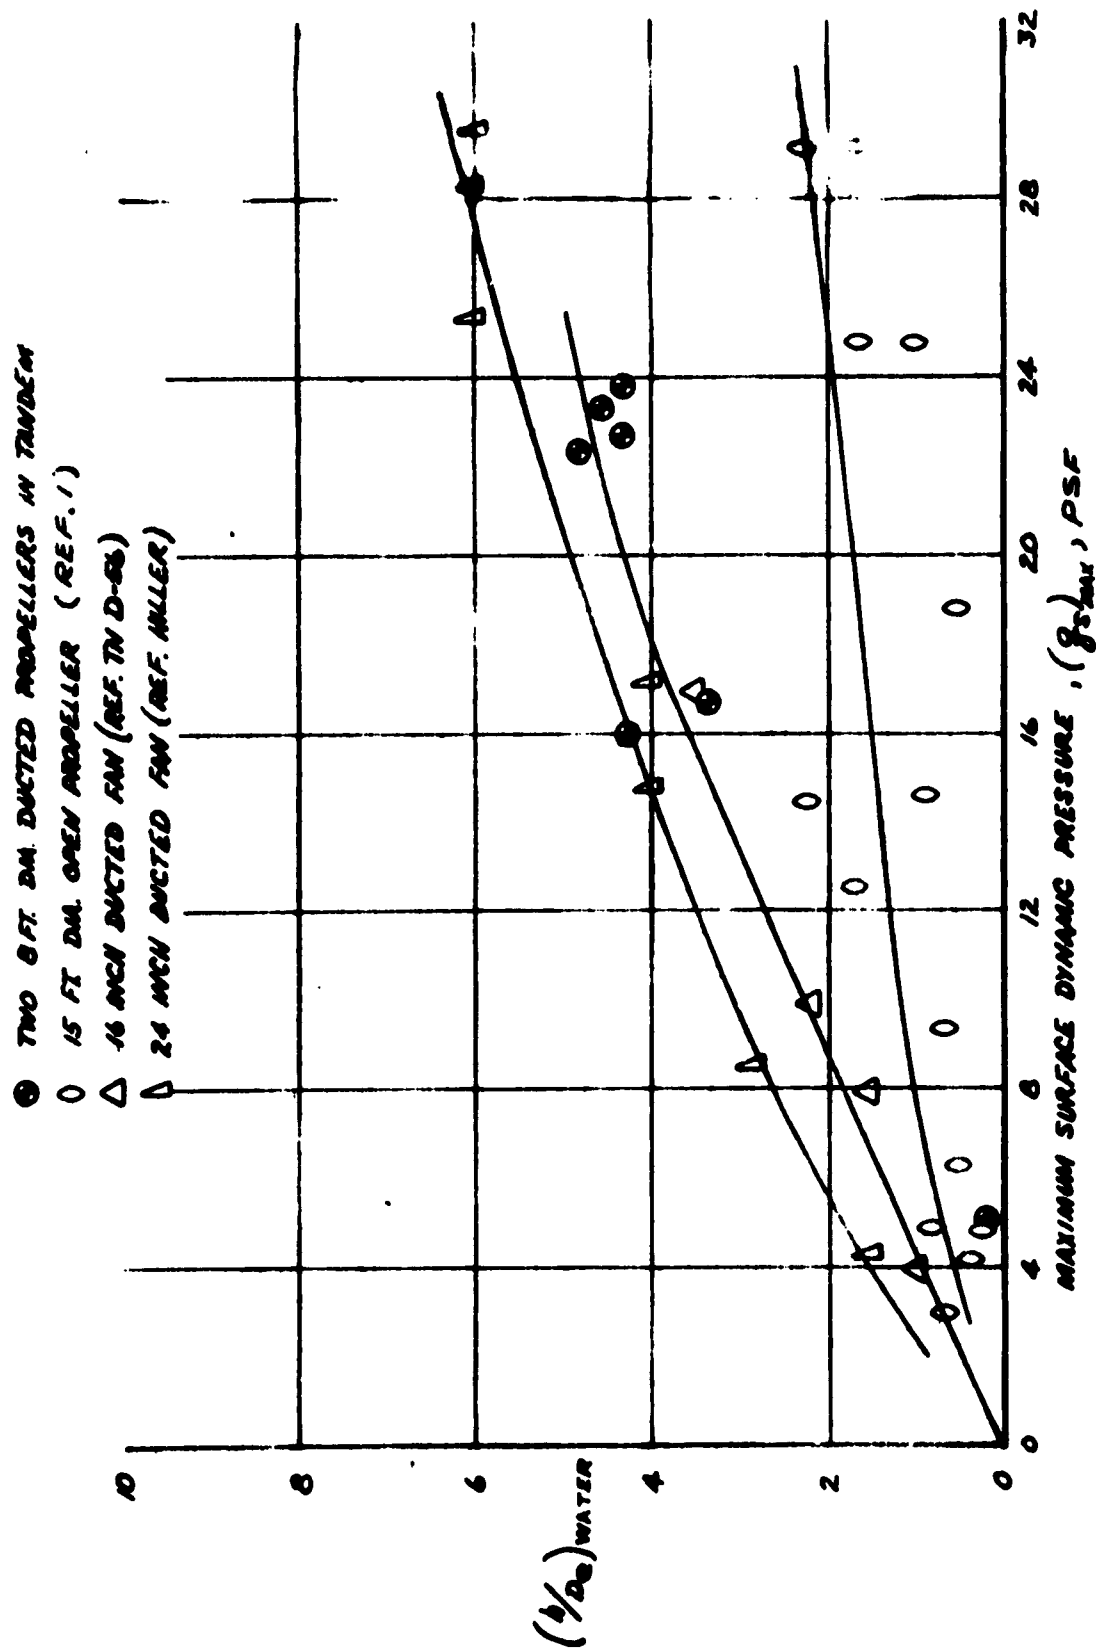
FIGURE 22. HEIGHT AT WHICH WATER SPRAY WAS OBSERVED FOR VARIOUS SURFACE DYNAMIC PRESSURES

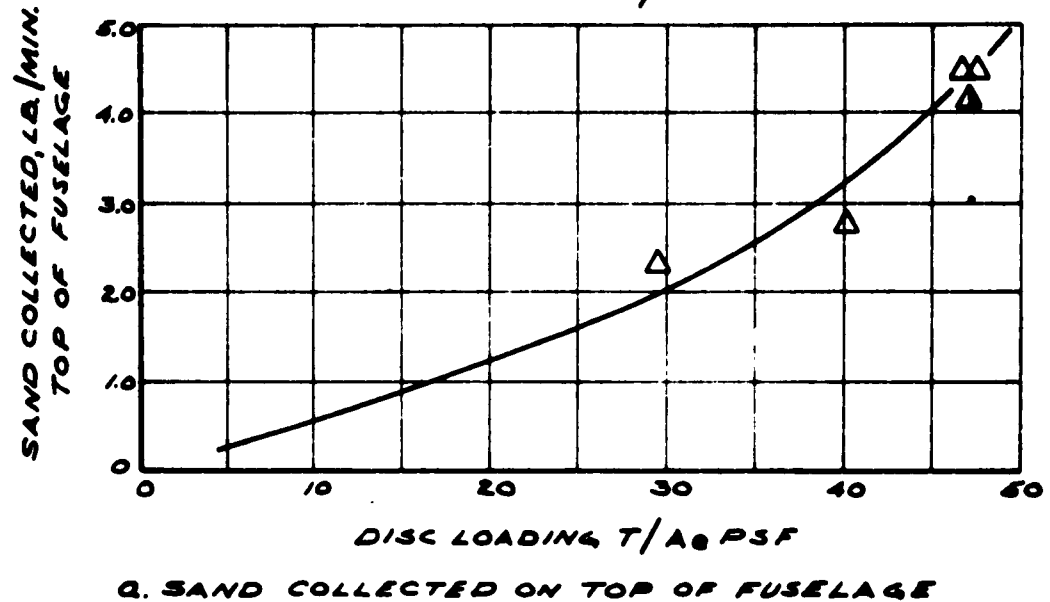
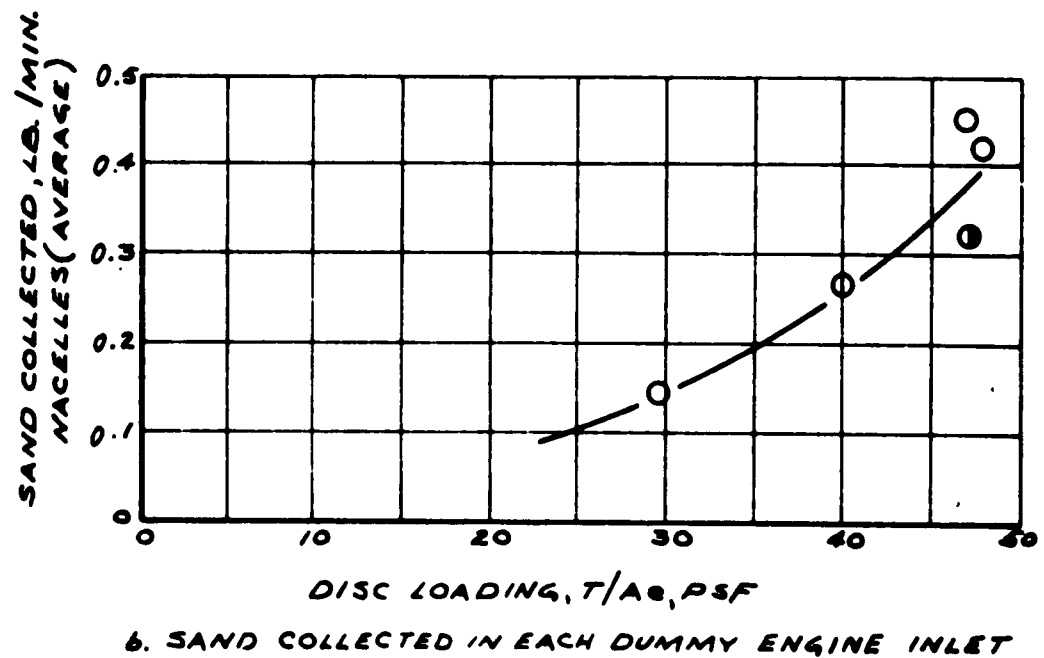
FIGURE 23. EFFECT OF DISC LOADING ON TERRAIN TRANSPORTATION

One of the downwash tests was conducted with a 20 knot, aft to forward wind. (All other tests were conducted with a wind of 5 knots or less). The effect of this wind may be noted from Figures 23 and 24. The quantity of particles was reduced while the percentage of large particles increased. It is felt that this result was due to the wind which scattered many of the finer particles away from the fuselage area.

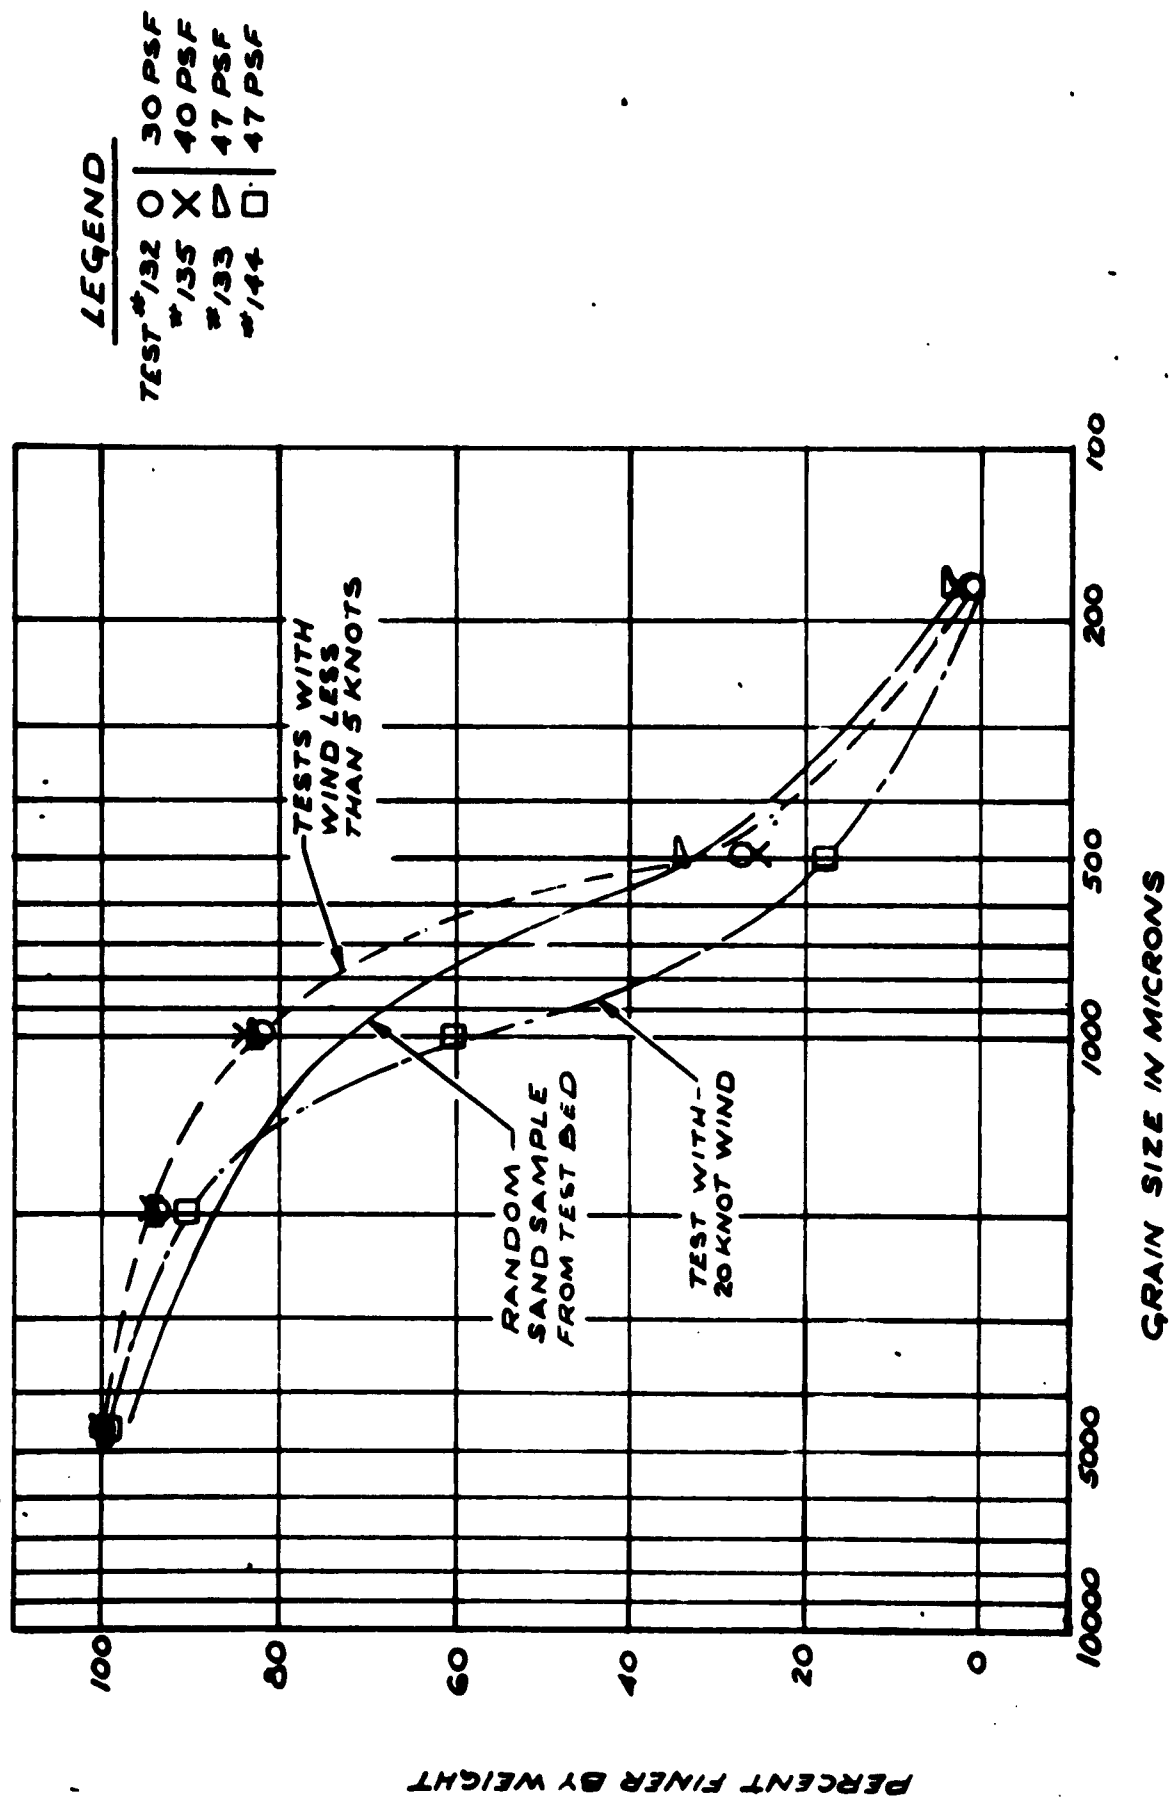
FIGURE 24. SIEVE ANALYSIS OF SAND PARTICLES COLLECTED ON TOP OF FUSELAGE FOR VARIOUS DISC LOADINGS

The size of particles collected (as shown in Figures 24 and 25) was generally larger than those particles collected in other downwash programs. This could be attributed to the strength of the upflow region being sufficient to propel a major portion of the available particles to the region above the fuselage. From Figure 24 it may be noted that almost 100

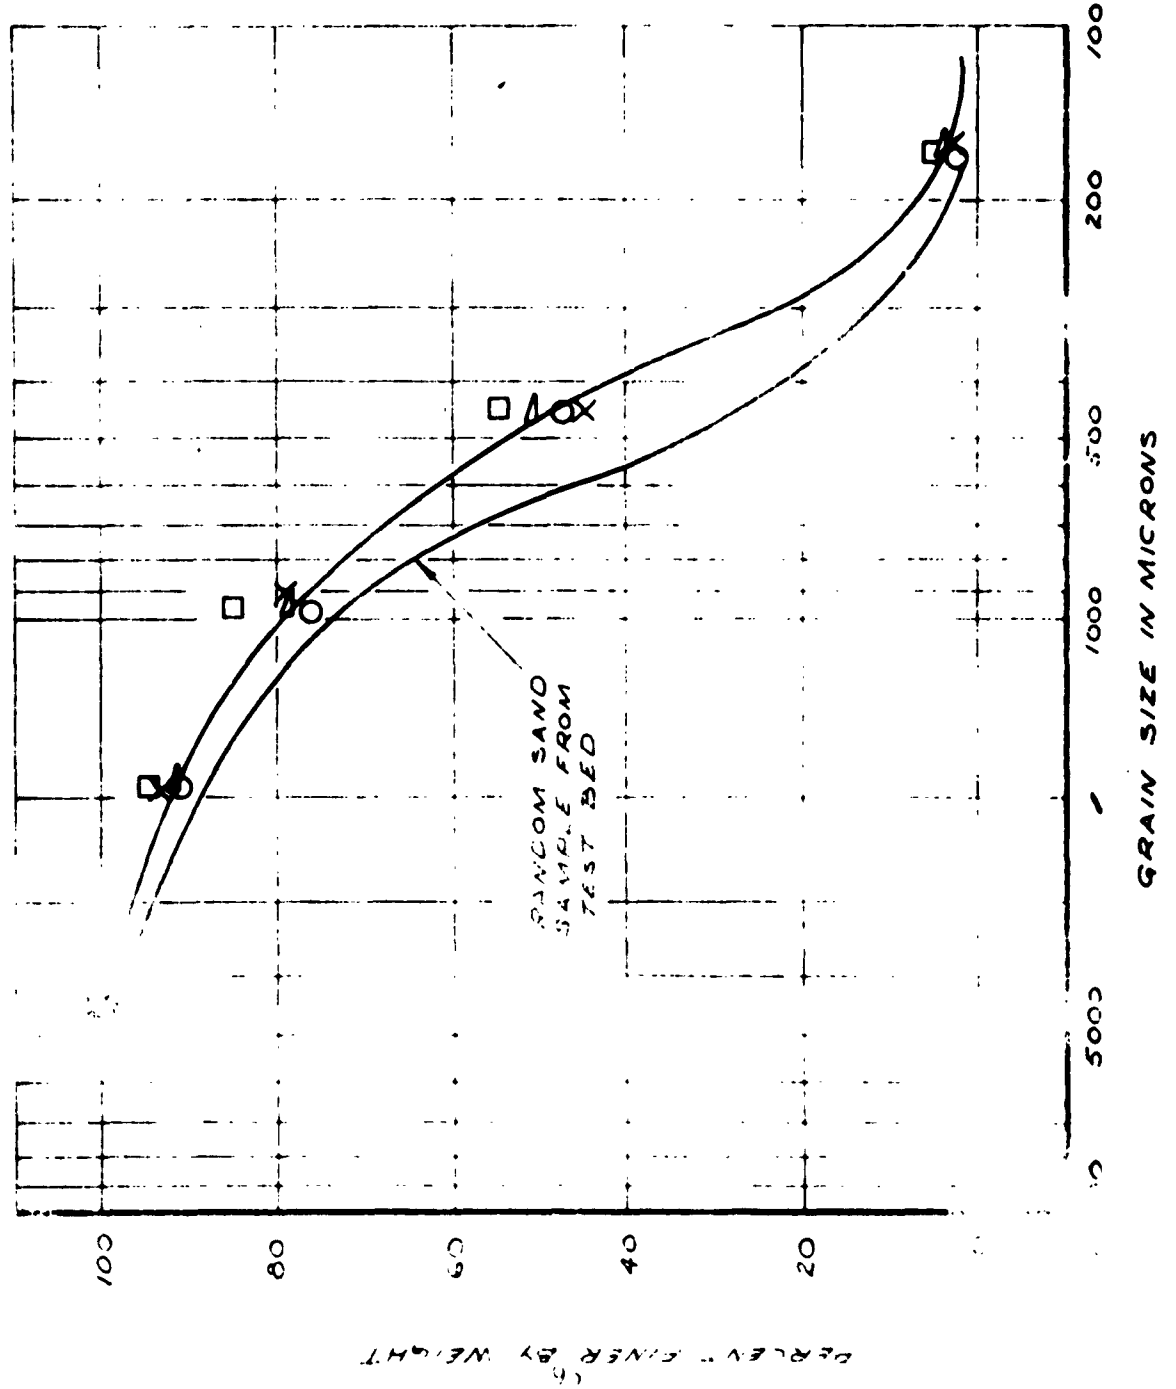
FIGURE 25. SIEVE ANALYSIS OF SAND PARTICLES COLLECTED IN ENGINE NACELLES FOR VARIOUS DISC LOADINGS

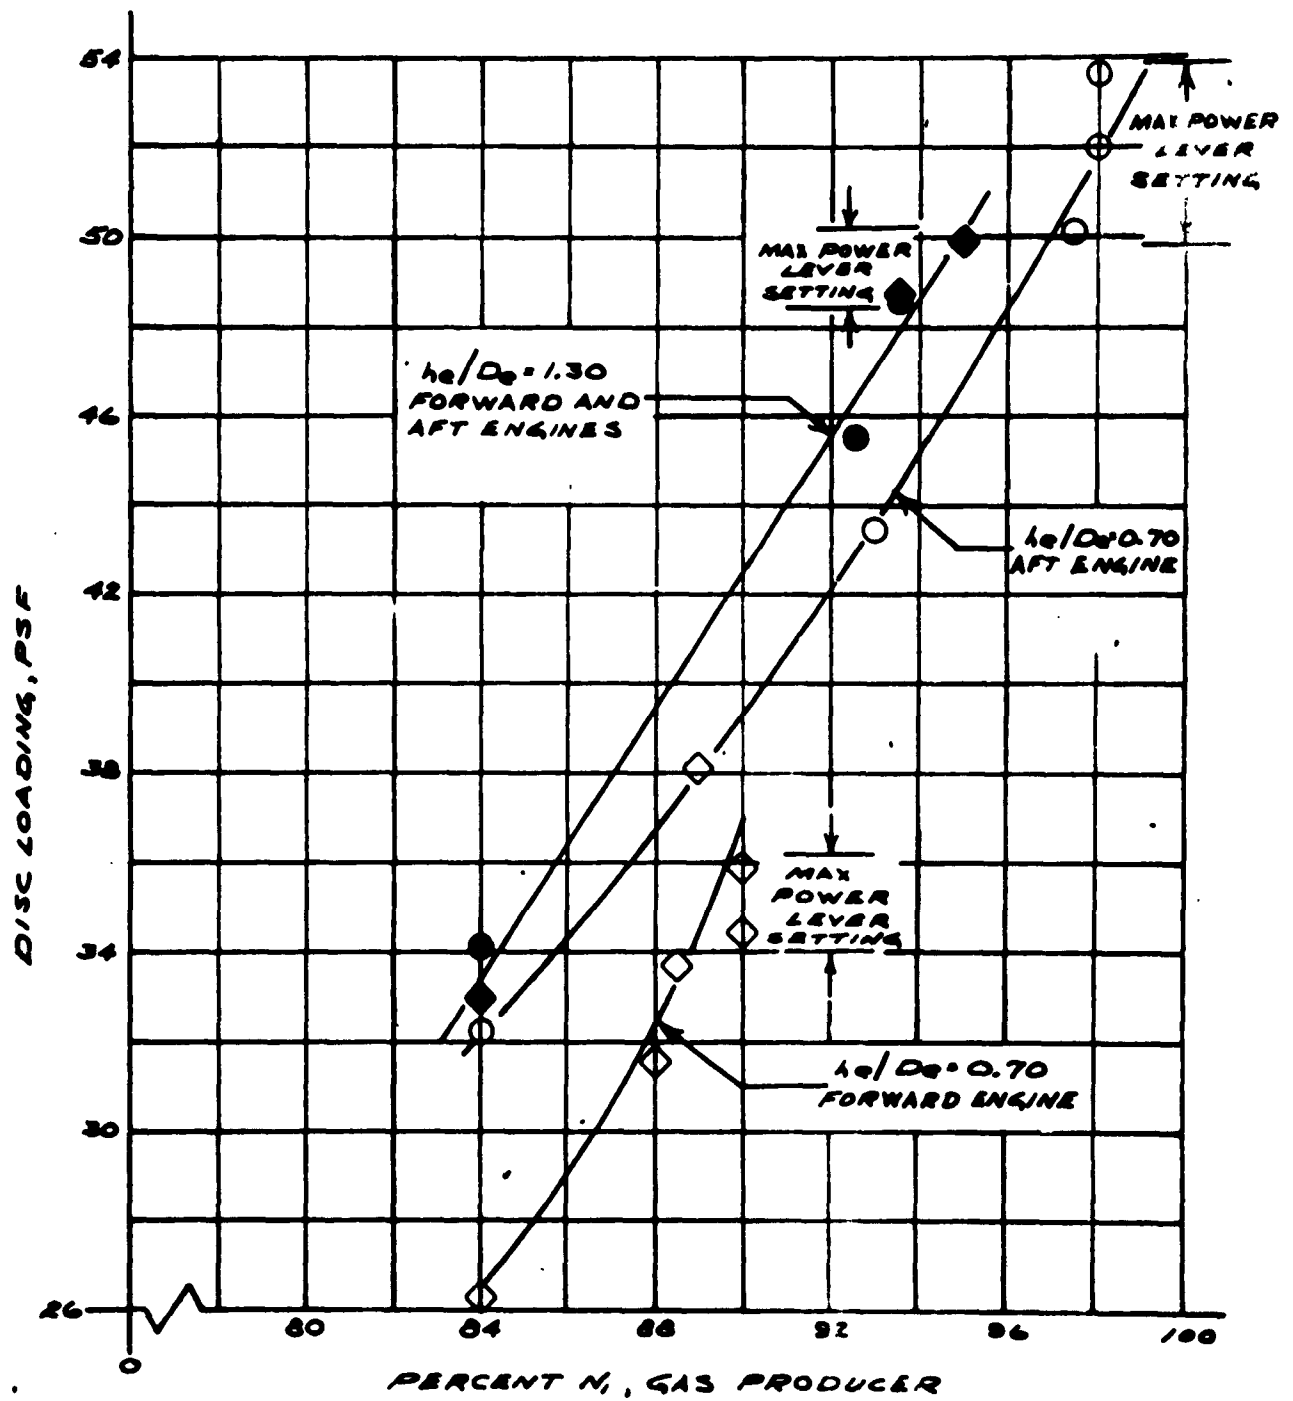
FIGURE 27. EFFECT OF OPERATING HEIGHT ON PERFORMANCE OVER WATER (T-2 CONFIGURATION)

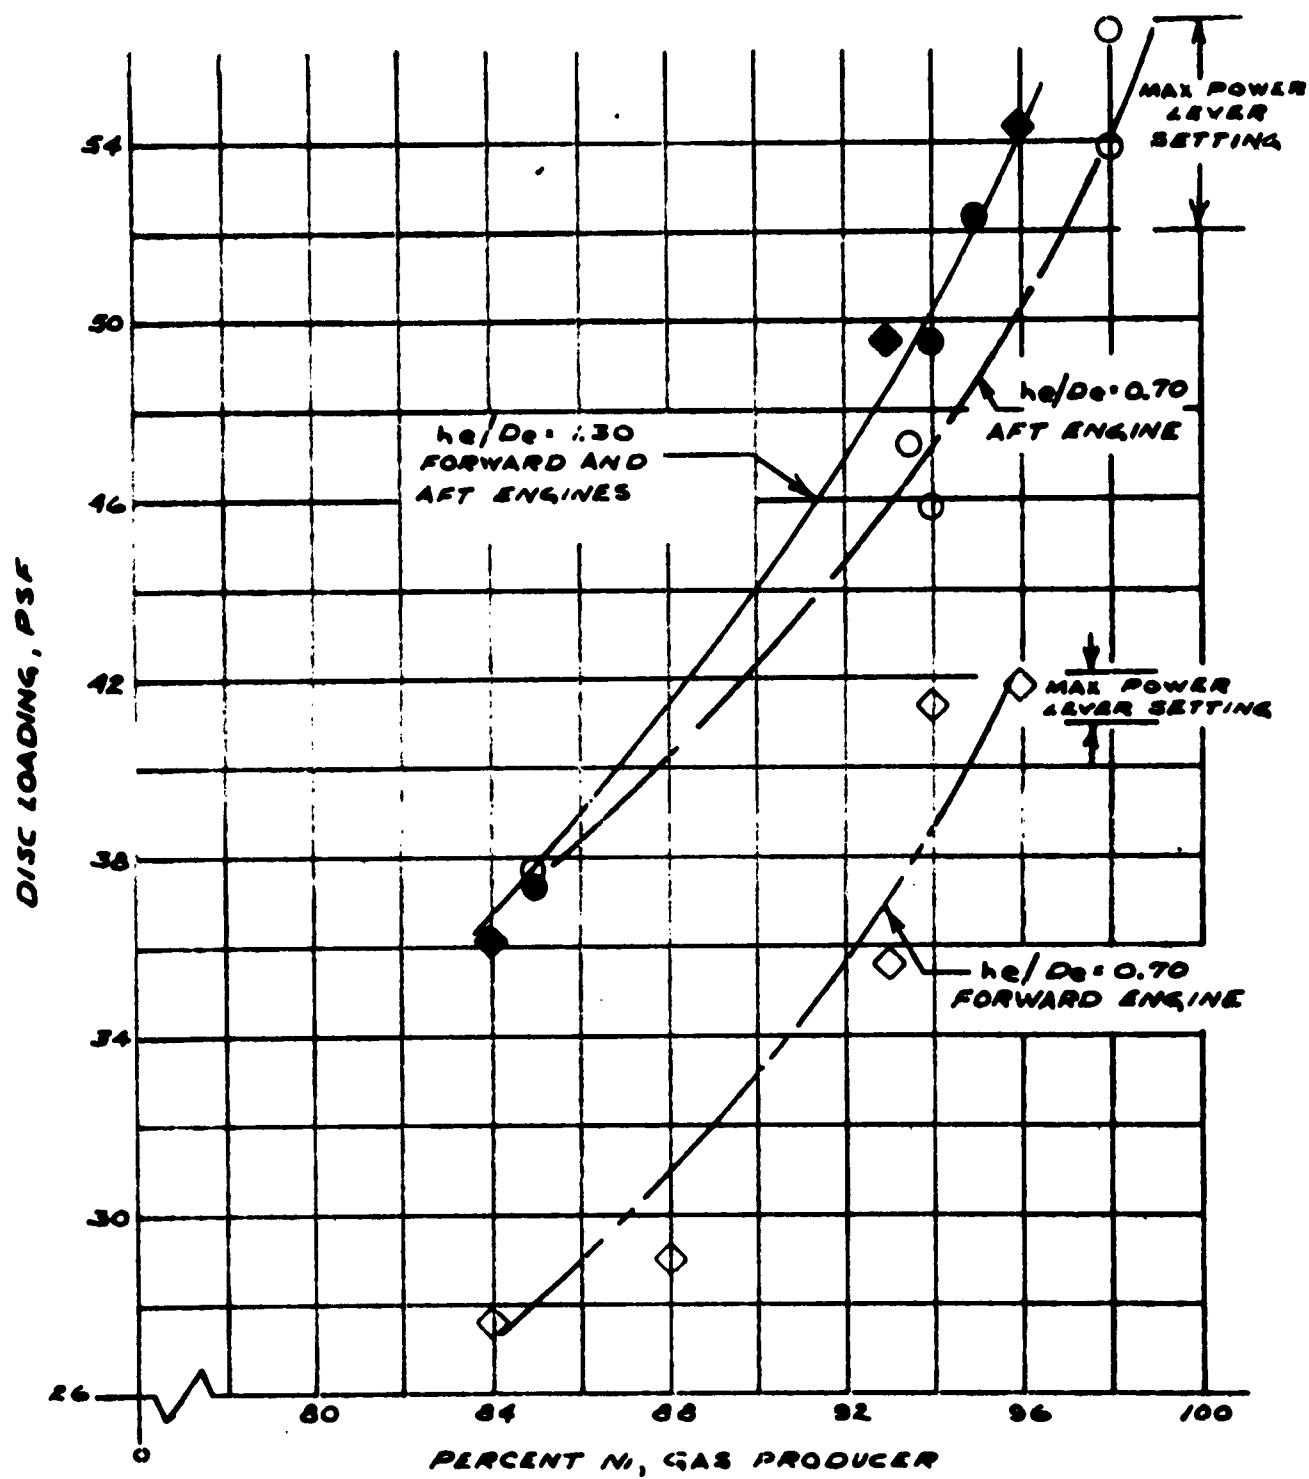
FIGURE 28. EFFECT OF OPERATING HEIGHT ON PERFORMANCE OVER WATER (T-5 CONFIGURATION)

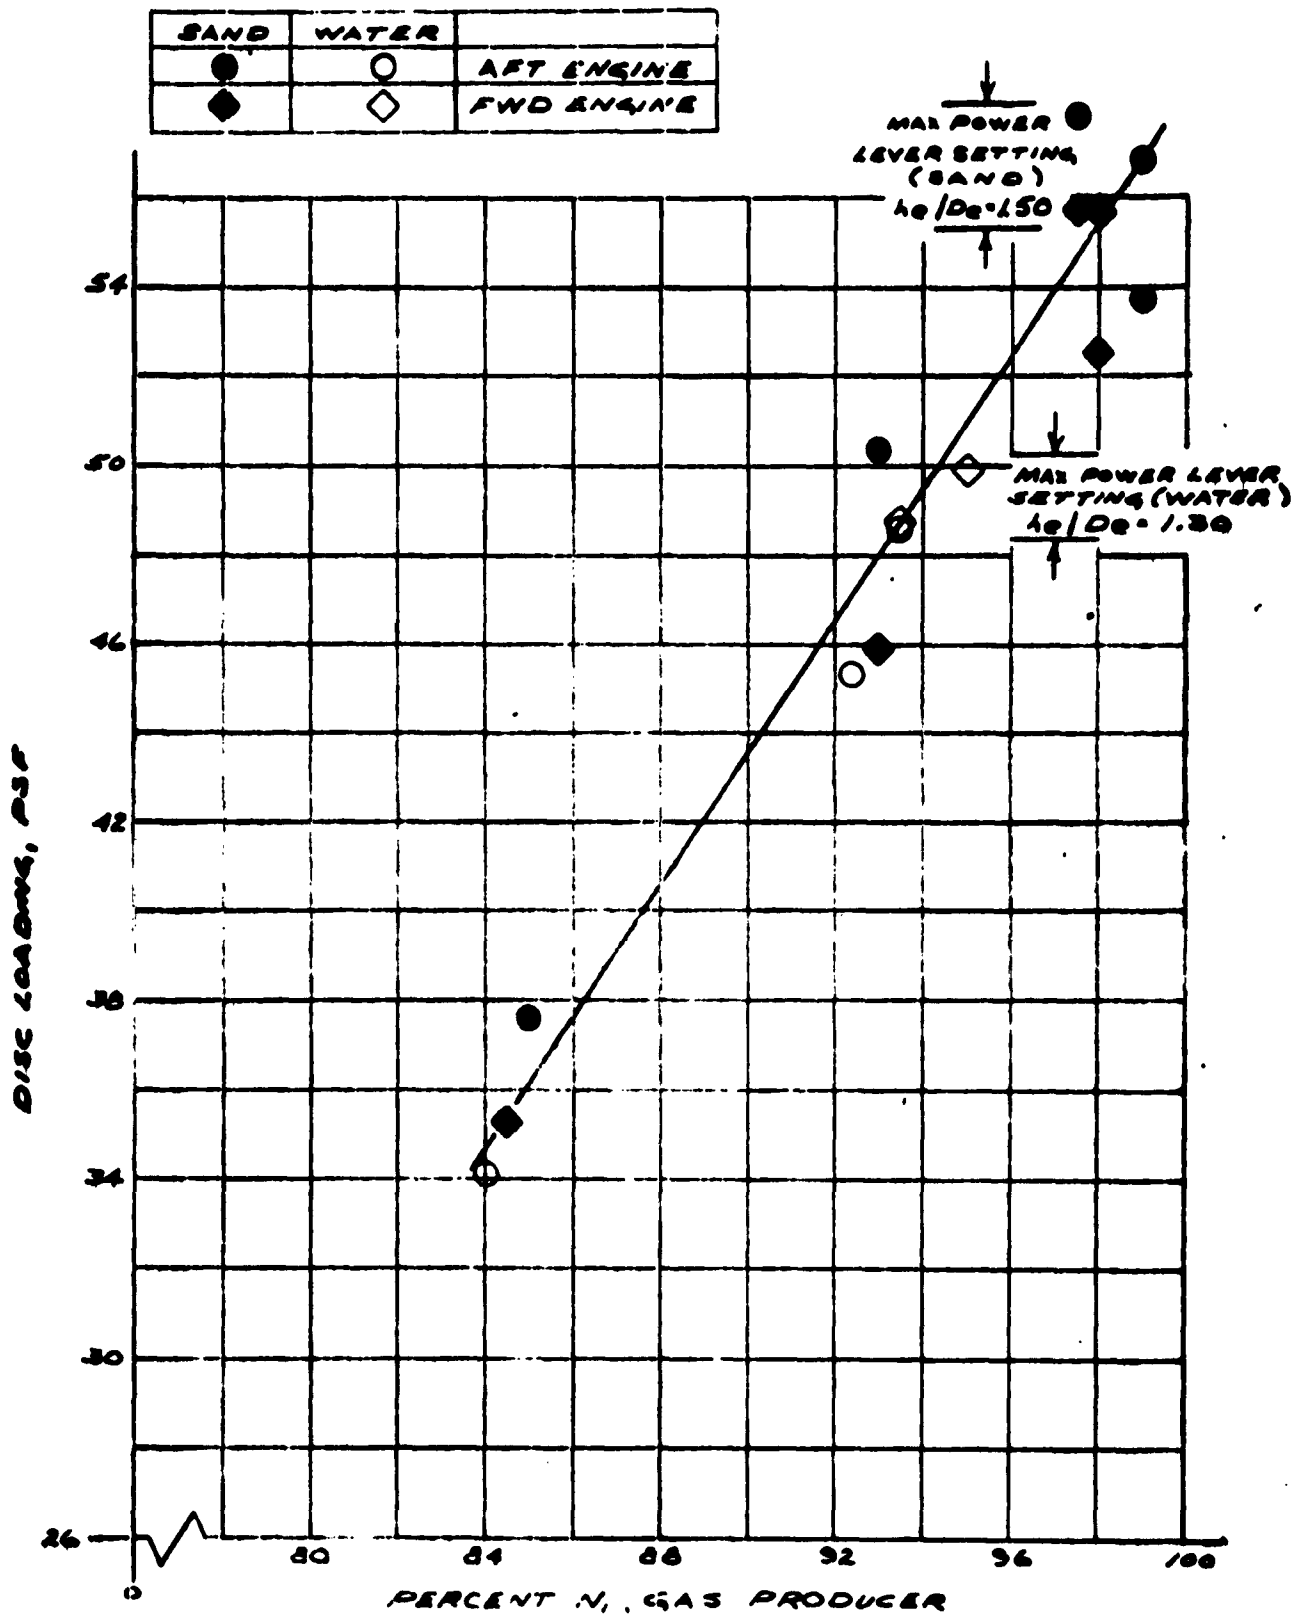
FIGURE 29. EFFECT OF TERRAIN ON GAS PRODUCER PERFORMANCE (T-2 CONFIGURATION)

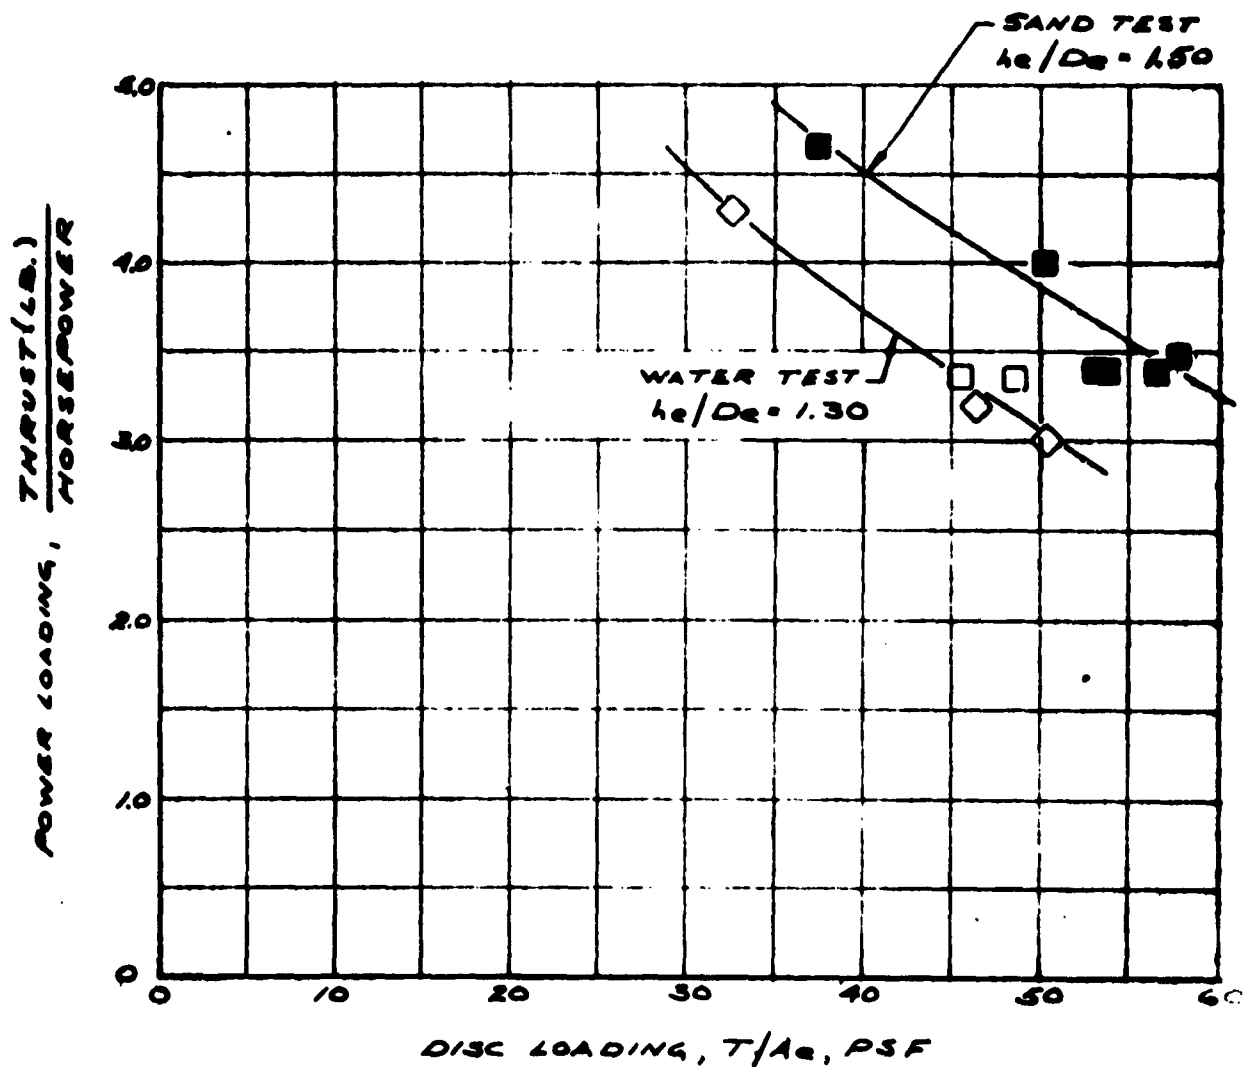
FIGURE 30. EFFECT OF TERRAIN ON AFT DUCTED PROPELLER POWER LOADING

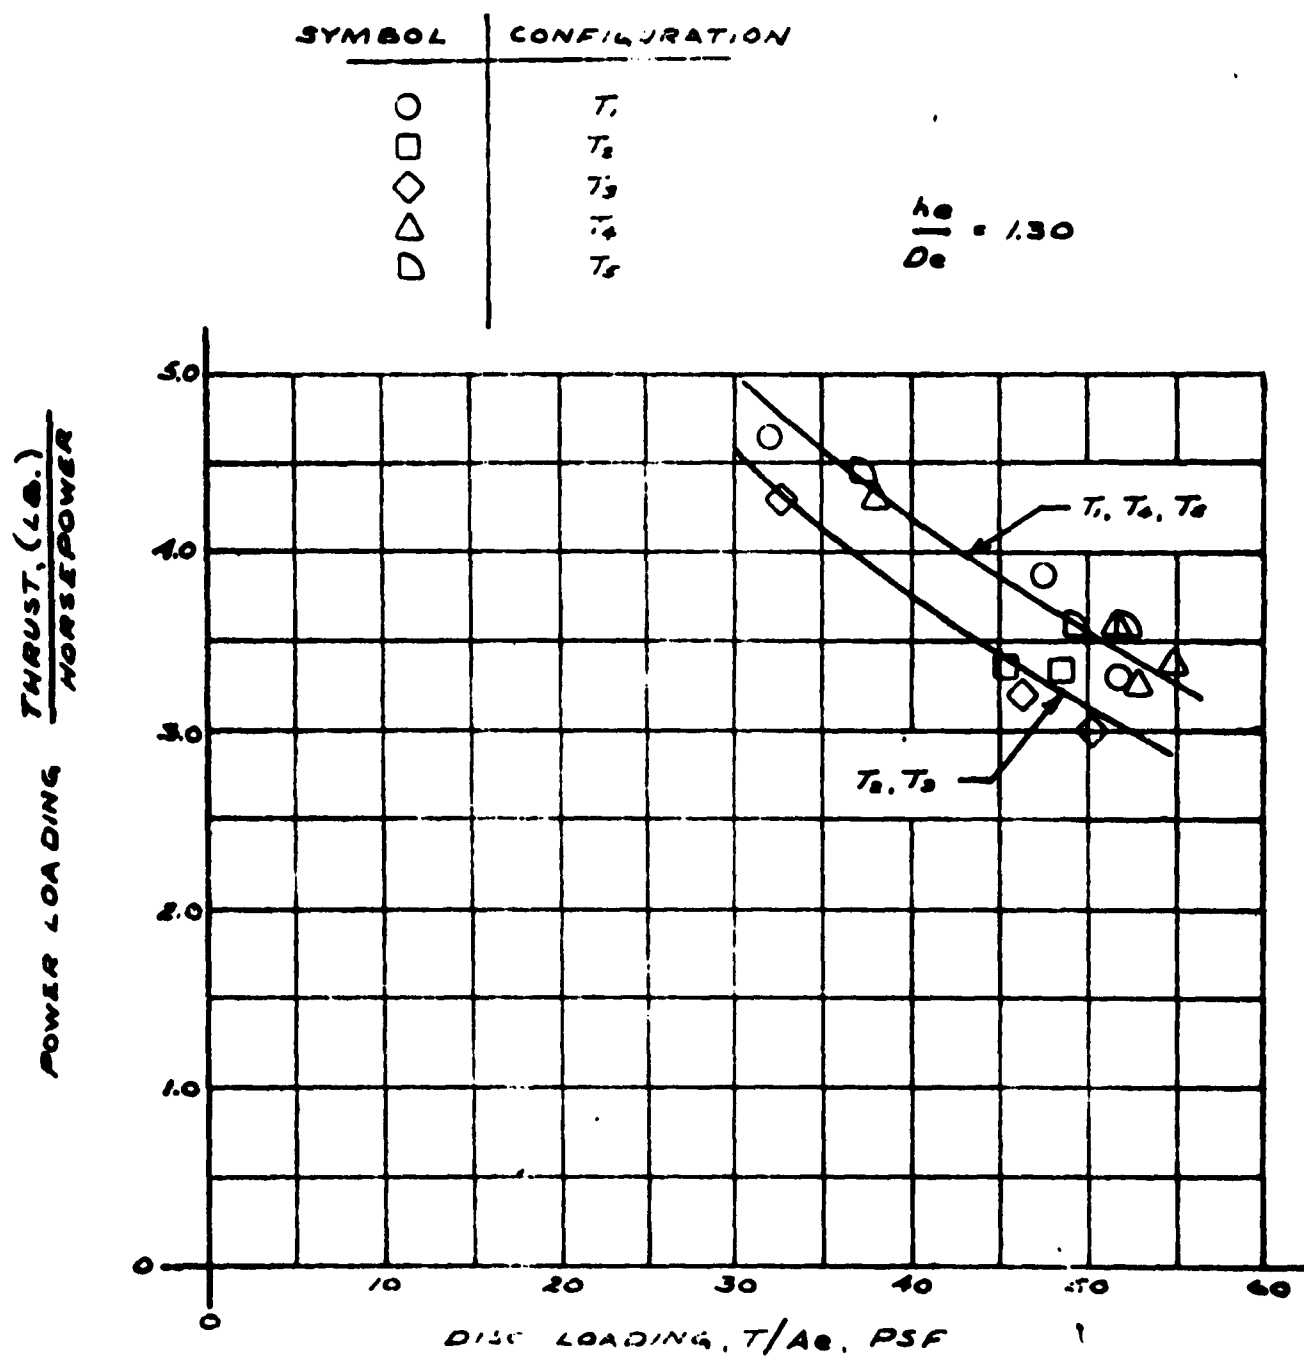
FIGURE 31. EFFECT OF CONFIGURATION ON AFT DUCTED PROPELLER POWER LOADING OBTAINED DURING TESTS OVER WATER
